## Core Plug Replacement

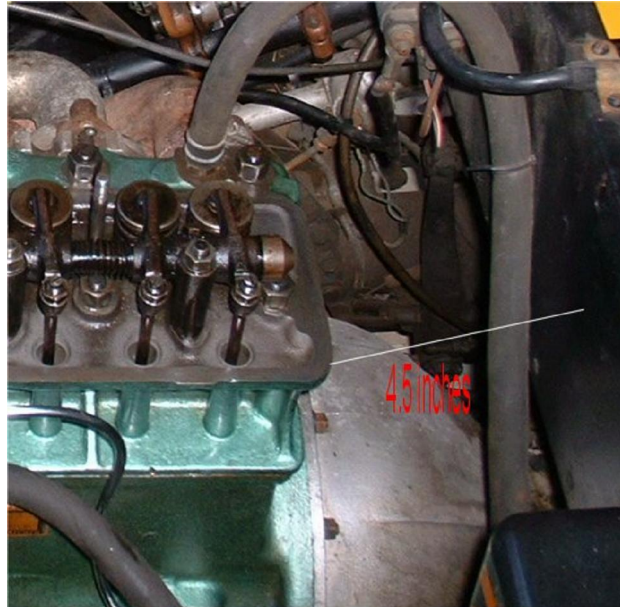
The head core plug, which is situated 4.5 inches in front of the aft bulkhead blew out, reason never discovered. Prior to the last resort of removing the head I decided to take a chance with a hydraulic set of jaws.
