Service instruction manual and more

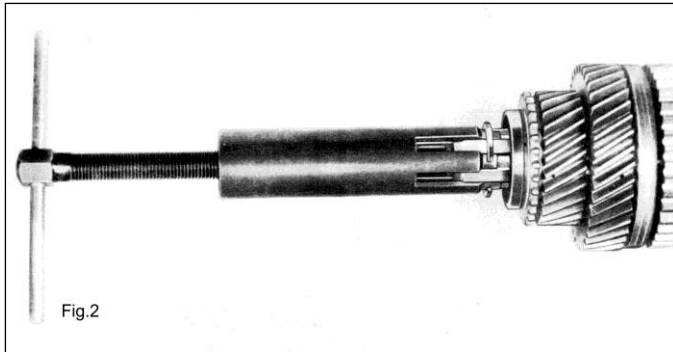
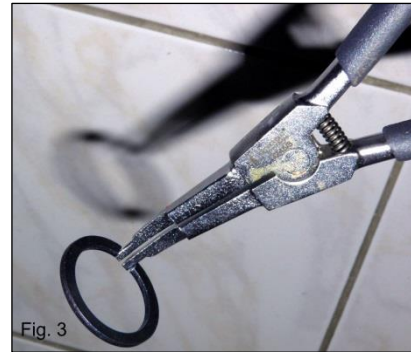
For extracting the main-shaft circlip (no 16 in the drawing) a special tool, as shown in Fig. 2, was designed to do the job.

The advantage of this original tool is that the circlip is expanded on supporting fingers so that it might slide with little clearance over the splines and stress on the circlip is limited. As a consequence the circlip can, in principle, be reused. However, such a tool is no longer available (and I also think its price would be prohibitive...) and therefore an alternative had to be found for extracting the circlip.

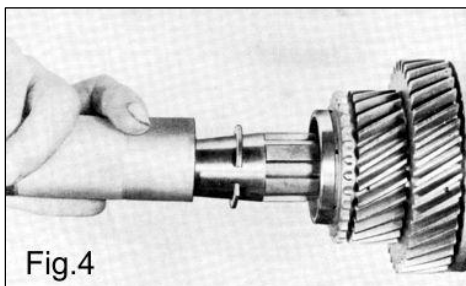
For putting the circlip back on the main shaft a further tool (Fig. 4) is described in the Service instruction Manual with a cone for expanding the circlip.

Those who own a lathe can make such cone themselves but I found that the Fig. 3 pliers, when used with some care do the job equally well. Since the circlip has to be put on the forward end of the splined shaft and is then pushed to its locking position, initial access is better so the risk of over-expanding the circlip is less than for the extracting procedure.

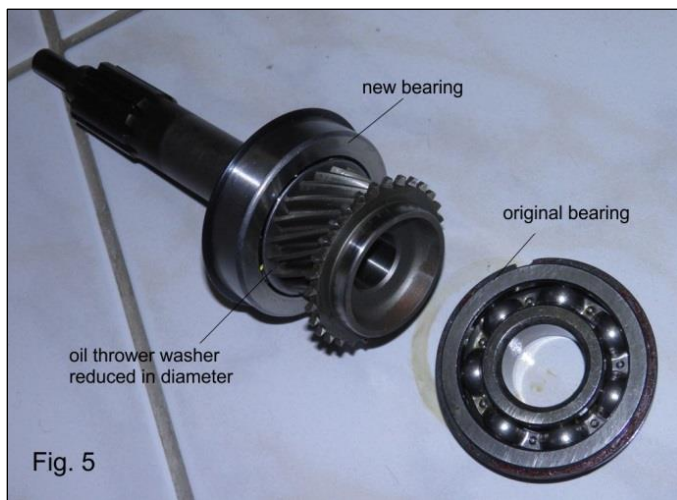
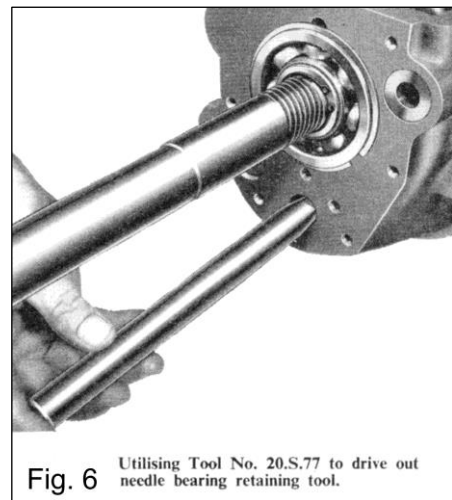
Have a good look at your new main ball bearings 4 and 33 because they might be of slightly different shape when compared to the original bearings. Namely those sold by most Triumph part sellers have a thicker outer ring and without modification the triangular baulk pin washer 5 and oil thrower washer 32 would risk rubbing against the respective bearing outer ring. The triangular baulk ring 5 should therefore be ground at its back to clear the bearing ring and the oil thrower washer 32 reduced in diameter to run free from the bearing ring.

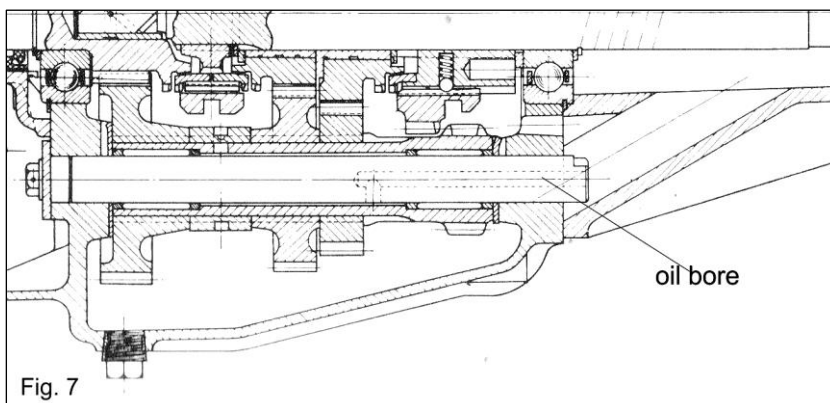
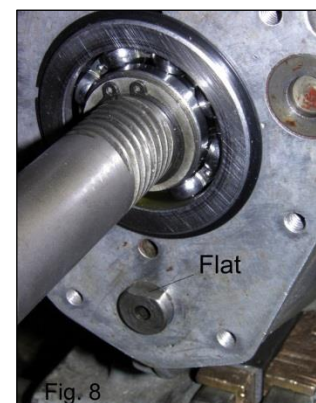
In Fig 7 it is shown that the countershaft 52 has an oil bore and for positioning of the outlet of the bore in the correct position it is important that the flat at the end of the bar 52 is at the top. Strangely enough this is not very well described in the Service Instruction Manual.

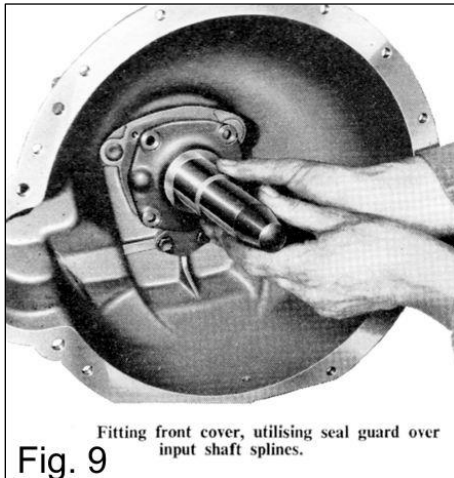
When fitting the front cover 71 with the lip seal 74 some care should be taken not to damage the seal by the splines. In the Service Instruction Manual it is recommended to use a seal guard as show in Fig. 9. The original lip seal is a leather seal and more prone to damage than the modern rubber lip seals. When taking care during

Fitting front cover, utilising seal guard over input shaft splines.

assembly I found that also without using the seal guard it is very well possible to mount the seal without damage.

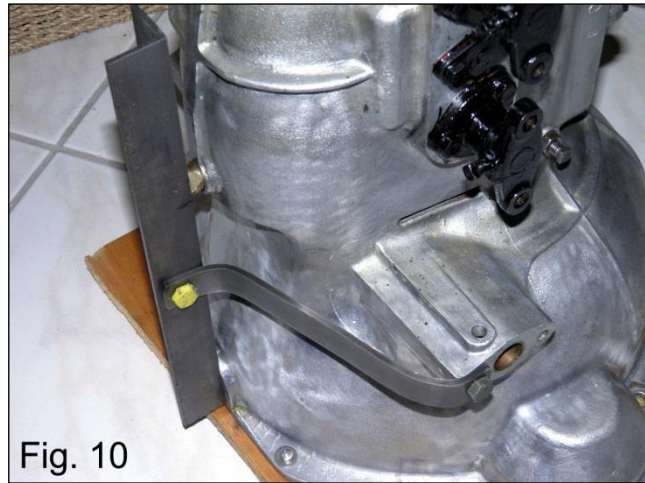
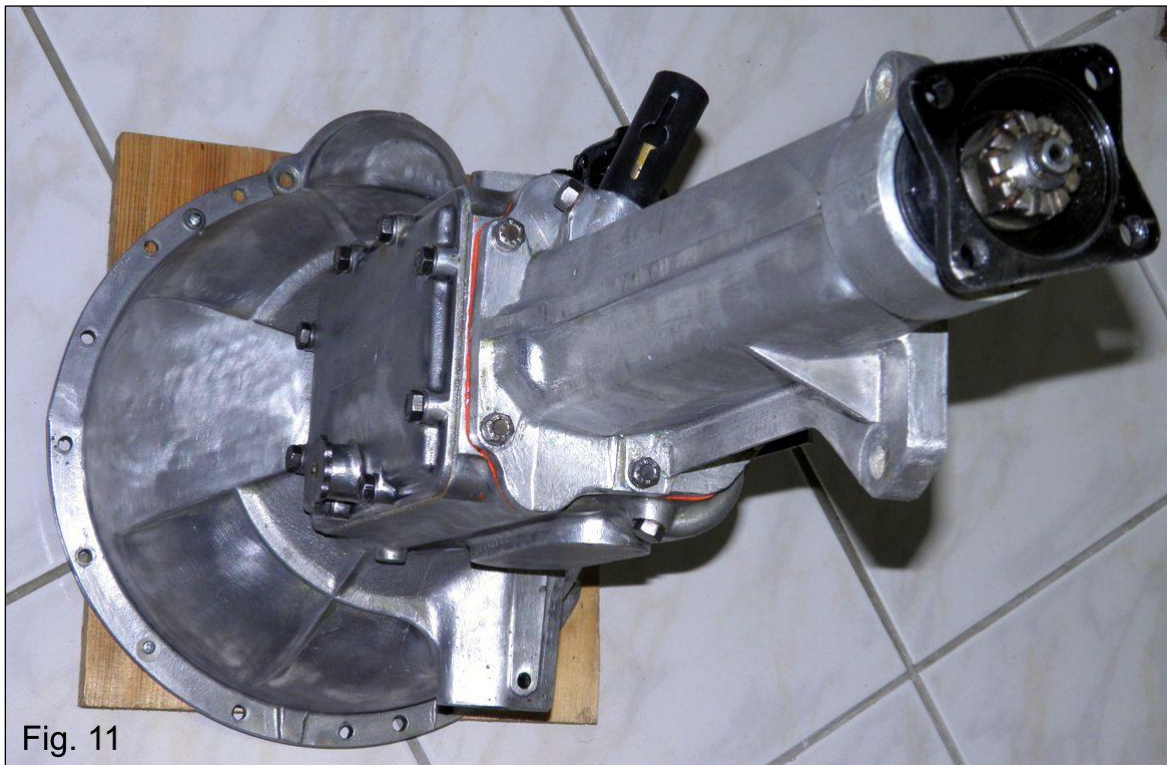
Manipulating the gearbox internals during assembly is much easier if the gearbox is stably held in a large vice. Fig. 10 shows an angle iron and strip and how these are fixed to the underside of the gearbox. The vice clamps on the angle iron. Fig. 11 shows the gearbox in its finished shape.
